# Manhole Inspection Summary

Manhole # S25E\_\_012MH

Insp Date: **8/7/07 8:29 AM**

**Location** Address: **1100 SARATOGA ST**

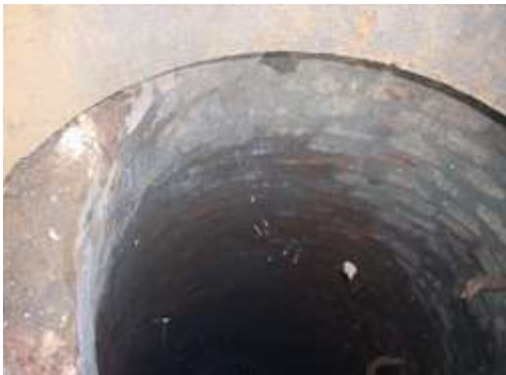
Defect 3

Condition: ☐ Sound ☐ Cracked ☐ Root Intrusion ☐ Loose Brick ☒ **Deteriorated**

Infiltration: ☐ None ☐ Joint ☐ Cracks ☐ Mortar ☐ Roots ☒ **Wall**

INFILTRATION OF CORBEL

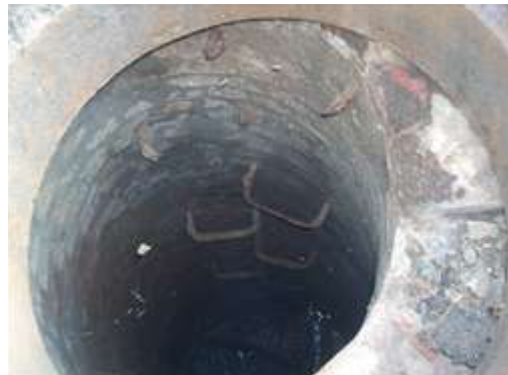
Defect 2

Count: **8** Missing: **2** ☒ **Corroded**

CORRODED AND MISSING STEPS

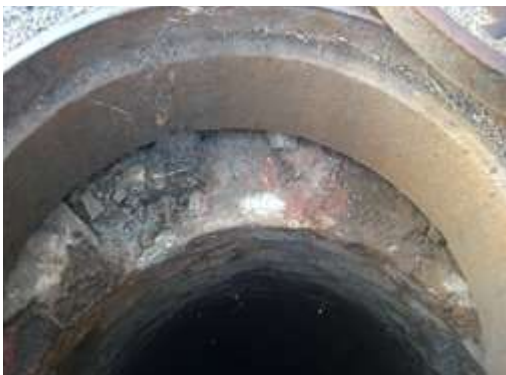
Defect 1

Offset: **4** (in.)

FRAME OFFSET AND DETERIORATED CORBEL

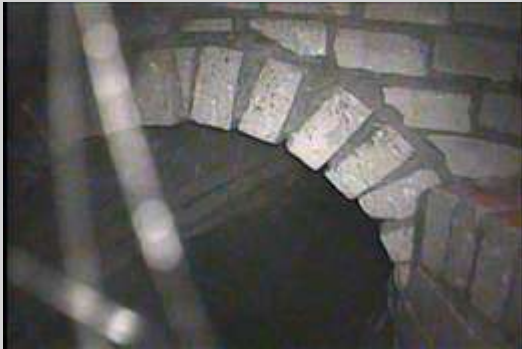
12 O'Clock Outflow

Pipe Height: **21.6** (in.) Rod and Bar (Angled)  
Pipe Material: **Clay** ☐ Pipe Lined  
Invert Depth: **17.24** (ft.) Flow Characteristics: **Slow**  
Deposits: ☒ None ☐ Mud ☐ Sludge ☐ Debris ☐ Grease  
Silt Depth: (in.) Deposits Extent:  
Infiltration: **None** Pipe Seal Cond: **Sound**

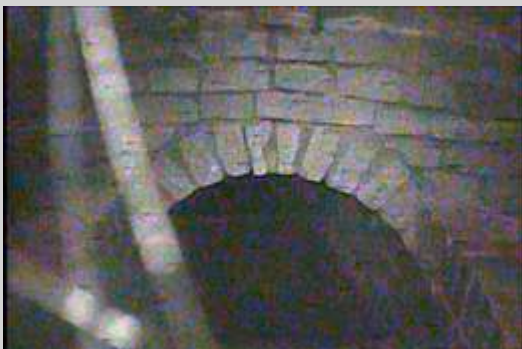
4 O'Clock Inflow

Pipe Height: **21.6** (in.) Rod and Bar (Angled)  
Pipe Material: **Clay** ☐ Pipe Lined  
Invert Depth: **17.13** (ft.) Flow Characteristics: **Slow**  
Deposits: ☒ None ☐ Mud ☐ Sludge ☐ Debris ☐ Grease  
Silt Depth: (in.) Deposits Extent:  
Infiltration: **None** Pipe Seal Cond: **Sound**

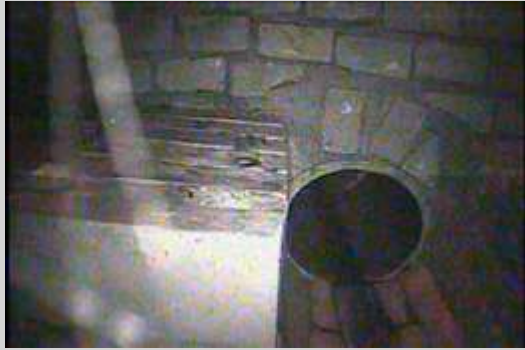
7 O'Clock Inflow

Pipe Height: **7.2** (in.) Rod and Bar (Angled)

Infiltration: **None** Pipe Seal Cond: **Sound**
